EPROM Field Replacement Guidelines

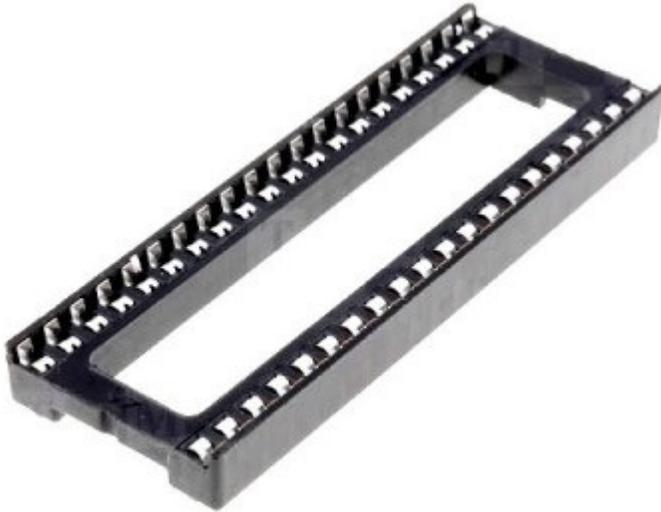
Photo of EPROM socket.

Note: Notch on lower left edge of socket. This notch must match up with the notch on the EPROM. There is a notch only on one side.

Also, one of the small end-edges of the EPROM will have a semicircular notch. This notch indicates the position of Pins 1 and 40. There is a similar notch on the socket on the Command Module.

Aligning the notches on the EPROM and the socket is of utmost importance. Failure to do this will most likely cause damage to the EPROM and, possibly, the Command Module. Any resulting damage of this type will not be covered under warranty.
